Architectural Documentation
of the
HEADLEY HOUSE

Annandale Historic District
Clinton Township
Hunterdon County
New Jersey

May 5, 2008

This project is the result of the need to document existing architectural conditions of the house before it is demolished as part of the proposed residential redevelopment project.

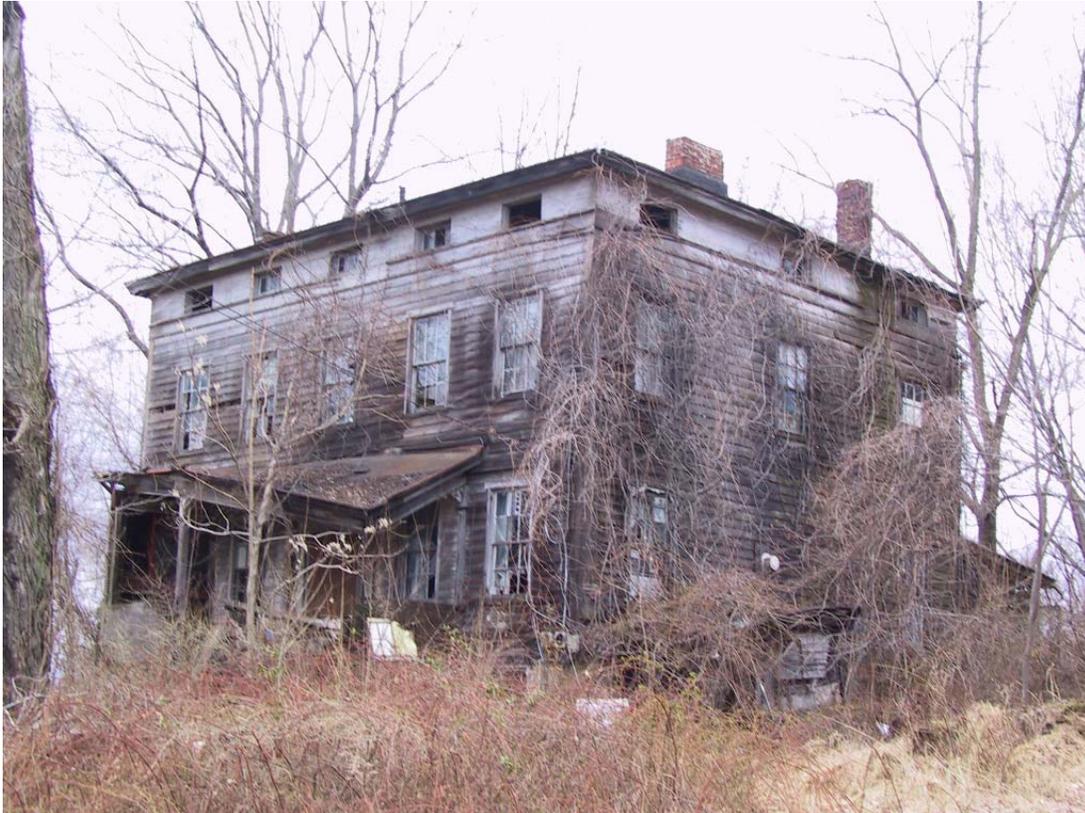
View looking Northwest

At the time of the survey, the site was abandoned, filled with garbage and graffiti from previous tenants and in a state of disrepair. The surrounding property was overgrown and the building unsecure. Despite the dilapidated condition, the house was found to be in relatively good structural condition with a good stone masonry foundation and timber frame structure.

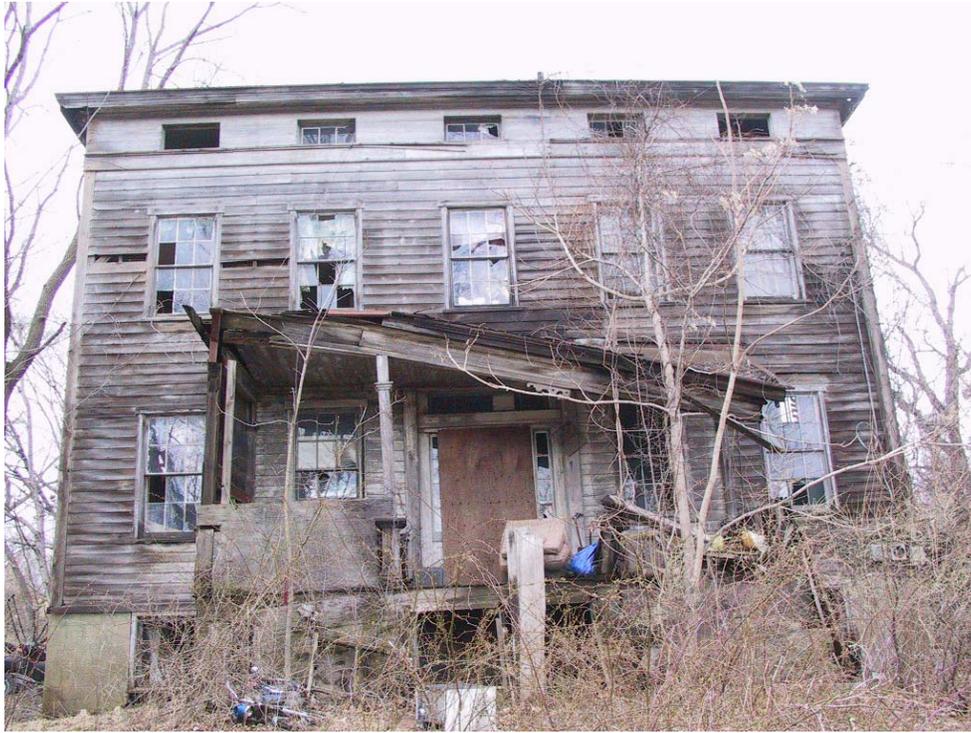
South Elevation

First and second floor windows are 6 over 6 sashes with the first floor being taller with elongated panes. The attic knee wall hosts 3 light sashes on the same rhythmic layout and the cellar windows are 3 over 3 with placement dependant on grade and foundation masonry conditions.

The foundation is a rubble with lime mortar and was built up to project substantially from grade. Its finish on the outside, which appears to be original, is a scored stucco which was done to emulate a cut stone.

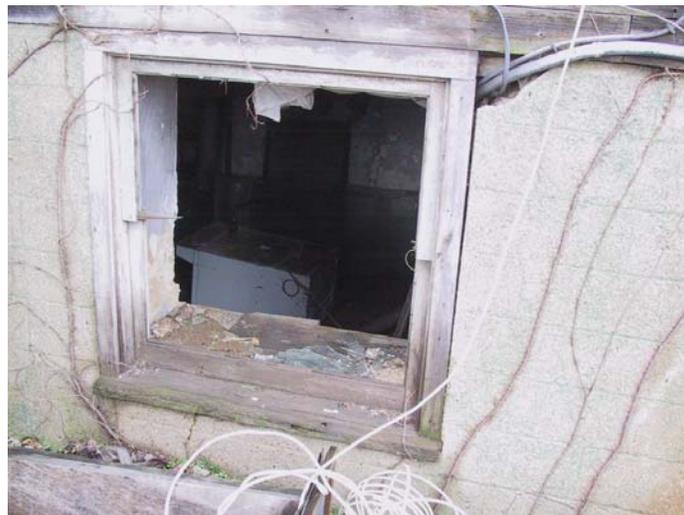
Southeast cellar window surrounded by scored stucco finish over the masonry foundation

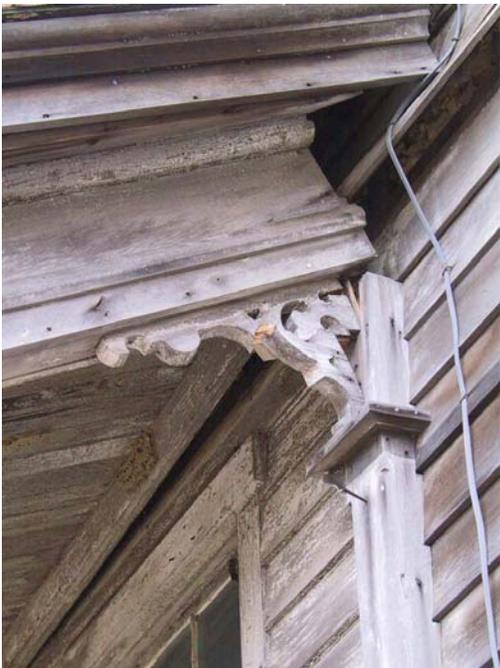
Front porch pilaster and entablature

The porch, now partially collapsed, has a flat roof, narrow board ceiling, deep entablature with a belt trim and box cornice and chamfered square posts with cap trim.

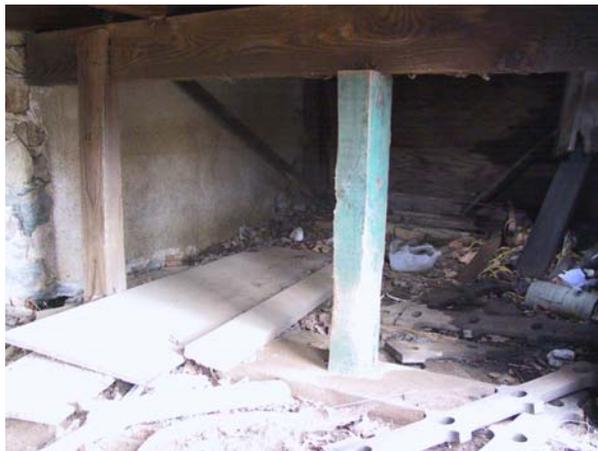
Below the front porch

Pieces of some of the details such as the brackets and decorative rails under the porch still exist but would require more inspection to document fully.

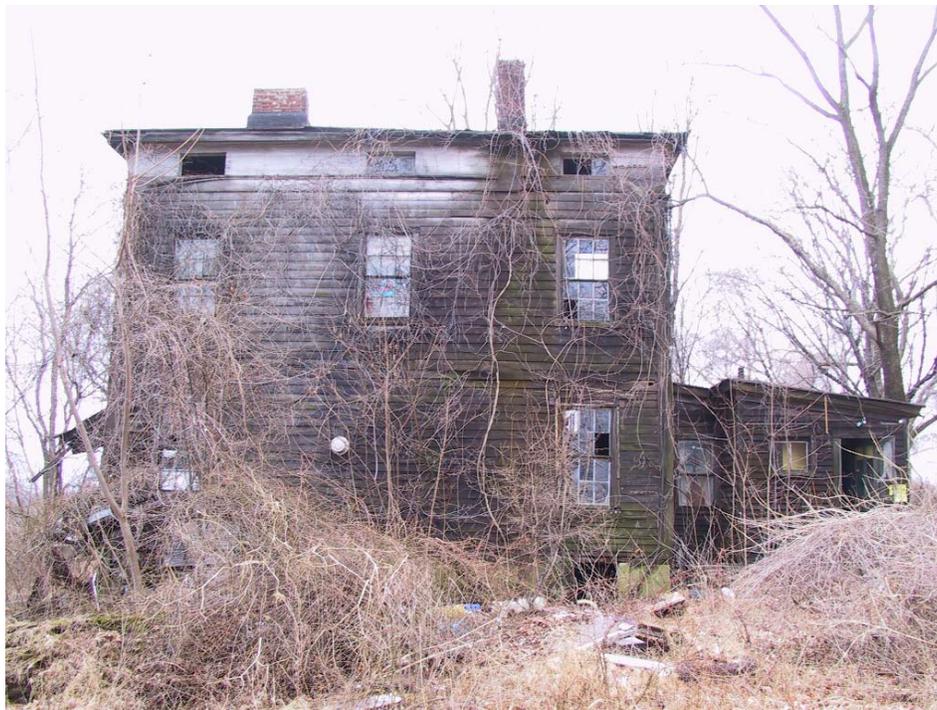
East Elevation

The siding is approximately a 5-1/2" exposure clapboard starting at a low water table and ending in a deep frieze which holds the attic windows and a belt trim. Corner boards are approximately 7" wide. The roof is a low-sloped hip with only the cornice visible from the ground level. Four brick chimneys penetrate the roof with the southern two being wider to accommodate cooking fireplace flues.

On the driveway side (East) of the house is a boarded up cellar access in the Southeast corner with what appears to be a 20th century shed addition adjacent to it.

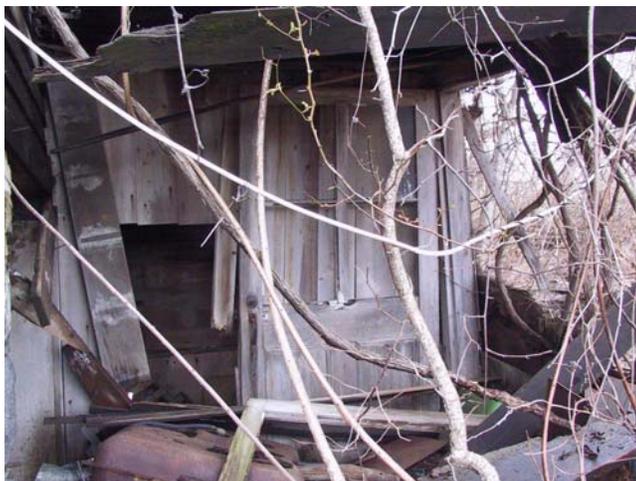
Shed addition looking North

To the rear, North side of the house are 20th century additions with shed roofs which house the rear entrance, kitchen and garage. No inspection was made to ascertain if these additions were replacements for an earlier wing, but visible evidence showed they were newer additions, poorly constructed and had no historical value.

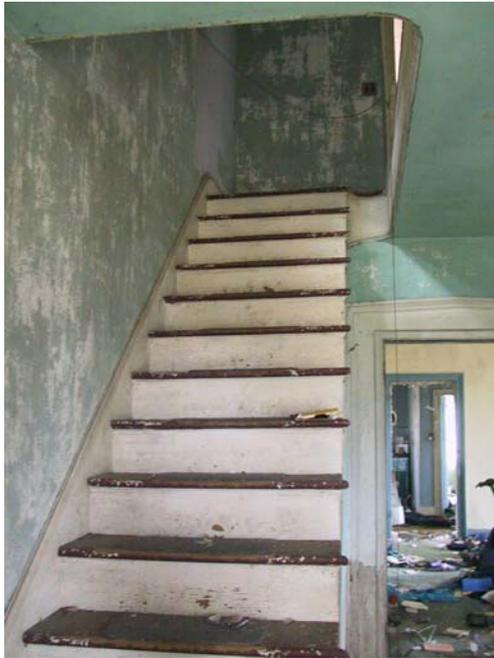
Center stair (Room 101) looking north
(the handrail has been removed)

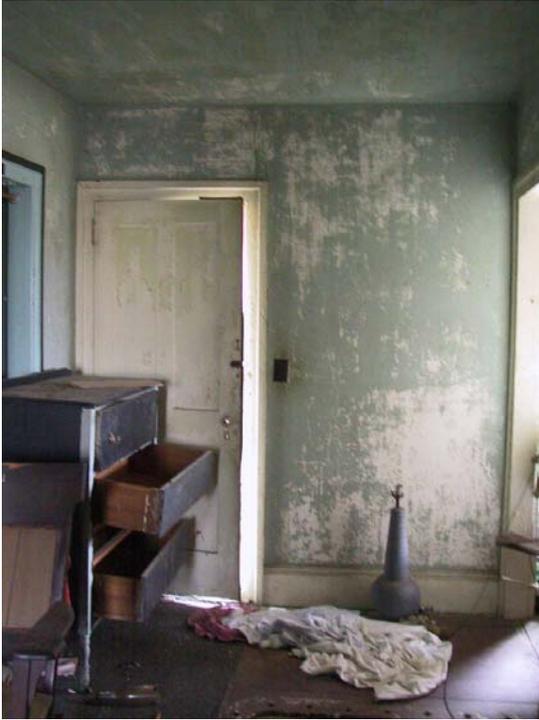
Stair hall Room 110 looking South
(stair rail has been removed)

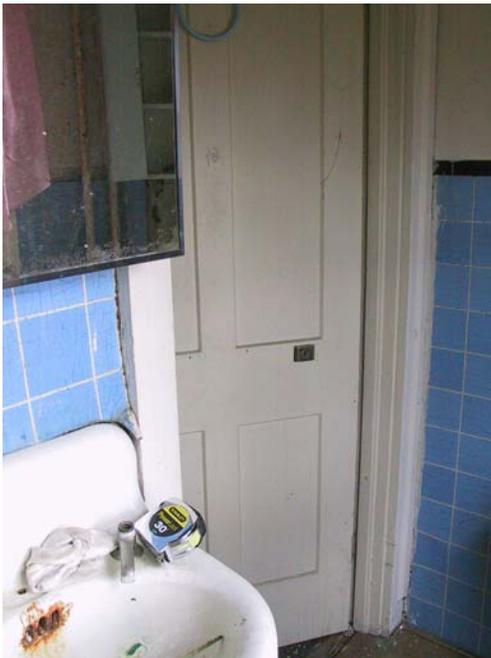
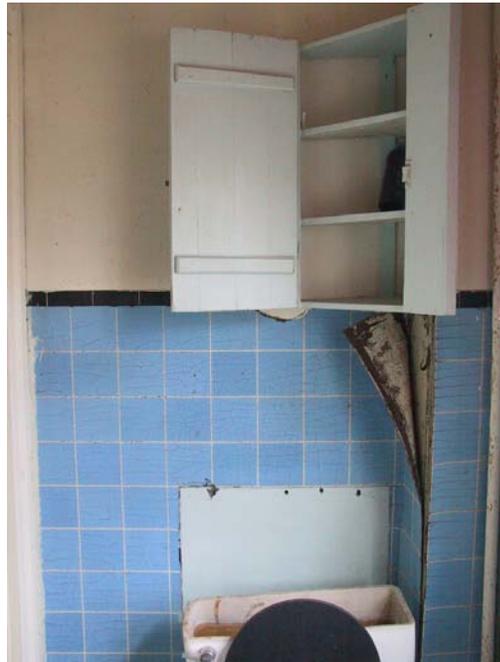
Room 111 had been altered to add a bathroom

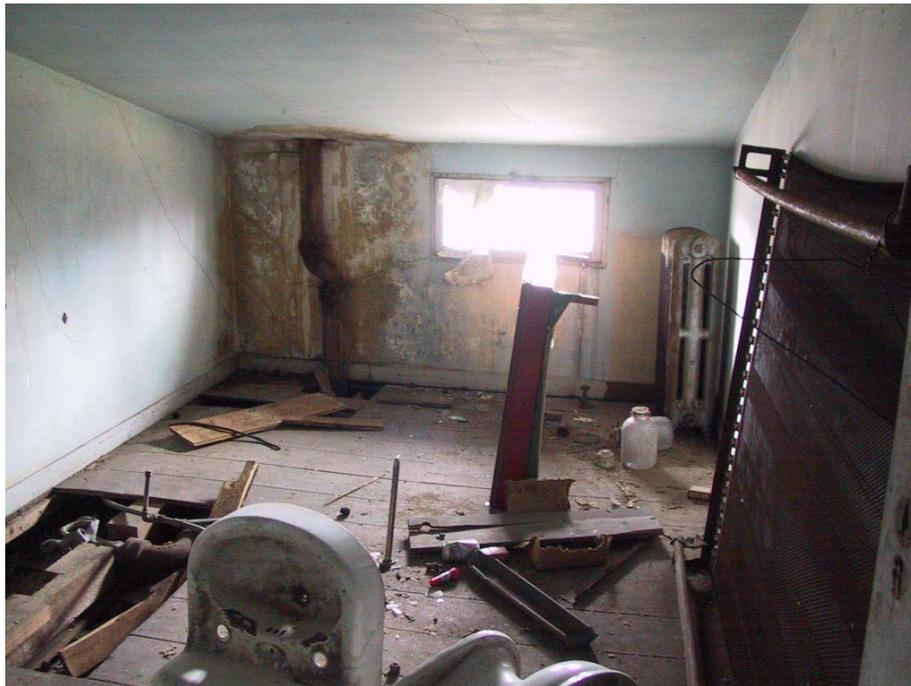
Room 120 looking South (had been altered for a bathroom)

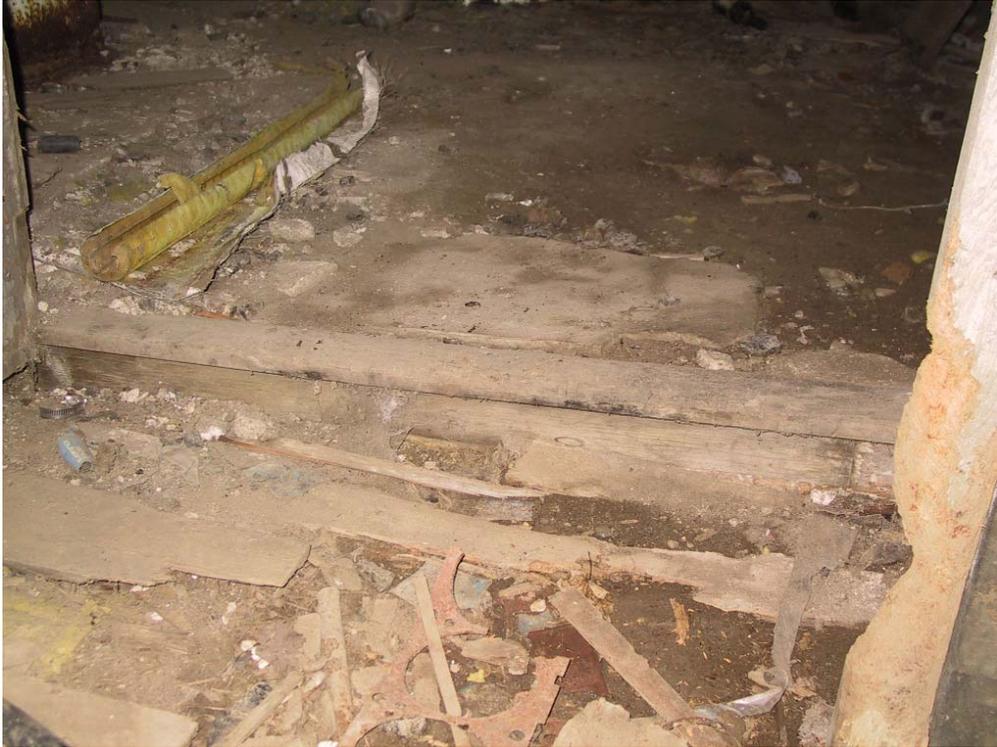
Wood threshold in Room B102 to Room B103.
Evidence suggests that there may have been a wood plank floor in Room B102.
