FOX-SEALS GENERAL STORE

**ANNANDALE, CLINTON TOWNSHIP
HUNTERDON COUNTY, NEW JERSEY**

HISTORICAL ASSESSMENT REPORT PRESERVATION EASEMENT PROJECT

DENNIS BERTLAND ASSOCIATES APRIL 2016

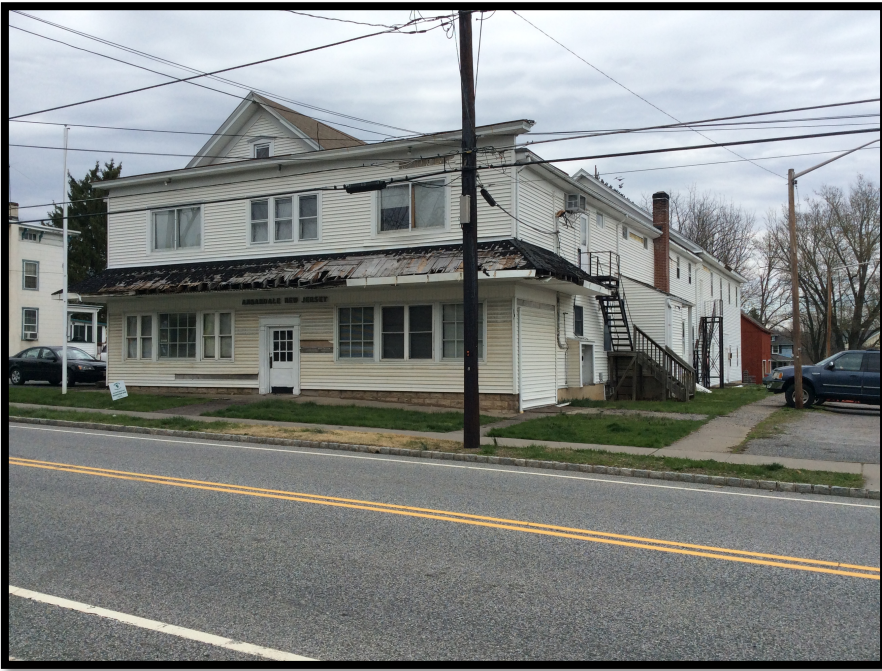
- **Windows.** The original regular fenestration survives on portions of the main block and rear wing. The west gable window with its raked hood and plain trim (Photo 1 and 2) is an original feature, as documented by the 1886 vignette (cover illustration), and the physical evidence of the interior framing; however, its 1/1 sashes are late 20th century replacements of the 2/2 originals visible in the vignette. Double-hung, 2/2 sash windows with plain trim remain on the north and east sides of the main block and rear wing at the second-story level (interior trim also remains), and are likely to be original, although the sashes might be early replacements (photos 1, 2 and 7). The main block's east gable window may be an early feature. The small 1/1sash windows on the north side of the main block on the first-story level are not original, and probably are contemporary with mid/late 20th century alterations.

Photo 1. Fox-Seal General Store, northeast view.

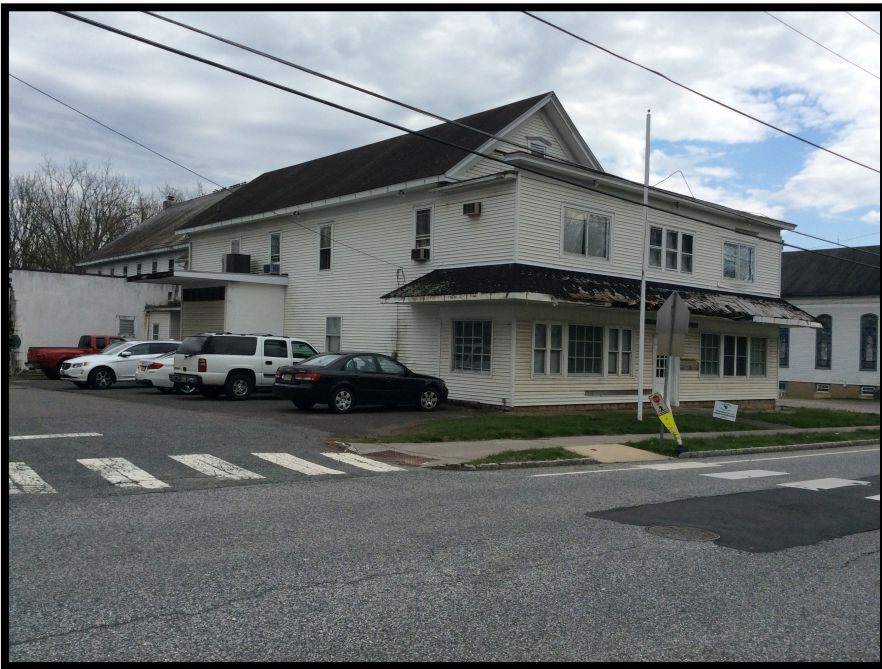
Photo 2. Fox-Seal General Store, southeast view.

- Restore/rehabilitate original 2/2 sash windows on north and east sides of main block and rear wing, or install replacements that match the originals in accordance with conditions analysis, physical evidence and historic documentation. Install matching 2/2 sashes in west gable window in place of modern sashes. Reconstruct windows on the other elevations, based on physical and documentary evidence, including two second-story front windows. New windows of similar design may be installed in place of inappropriate modern windows on the first-story of the north side of the building or elsewhere on south and east side of the building, as required to accommodate the new use program.

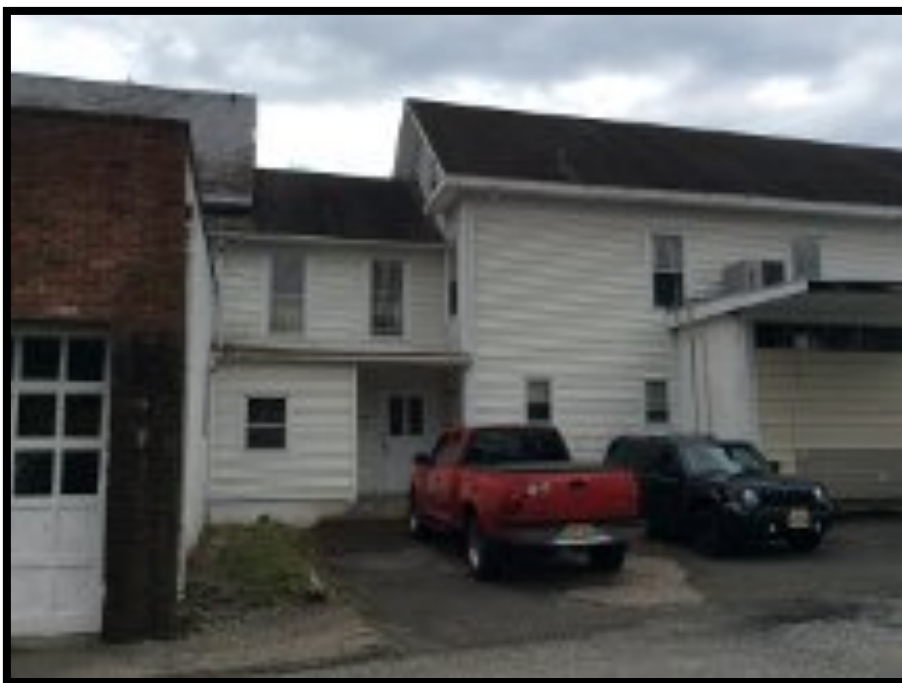
The original form of the 1880s store main block and rear ell (including "footprint," height and roof pitch) remains intact and can be readily discerned when viewing the building from its north side (photos 2 and 3). Original exterior finishes also survive on portions of the north, west and east sides of the main block and rear ell, although largely covered by modern finishes, and early finishes and features, or evidence of them, may survive behind the later additions.

Photo 3. Fox-Seal General Store. Original store and rear ell, SE view.

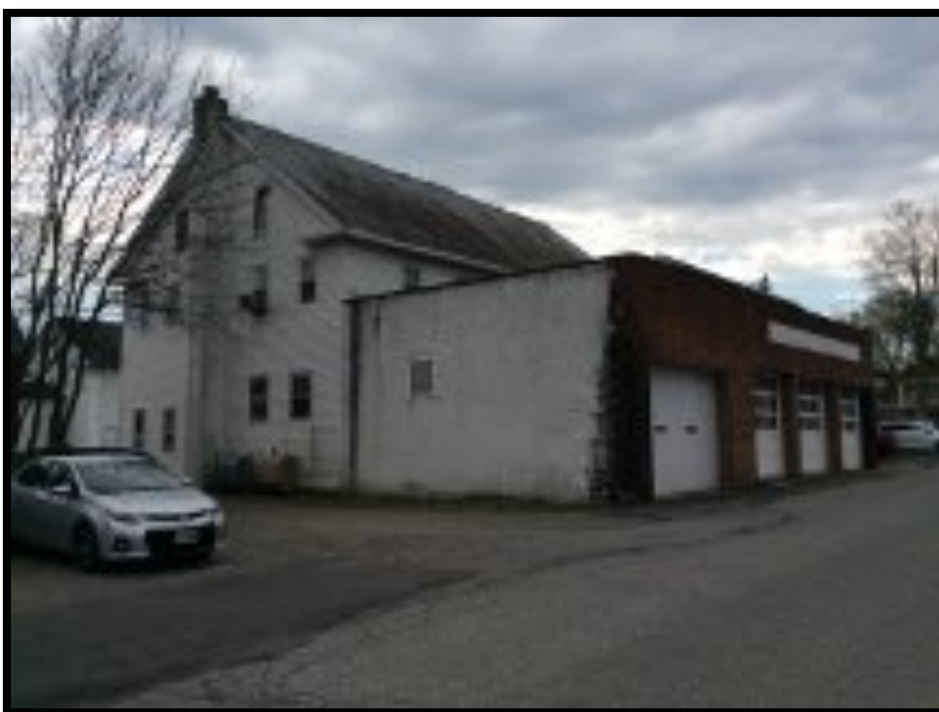
Photo 4. Fox-Seal General Store. Rear store block and firehouse additions, SW view.

- Removed later appendages, and carefully inspect exposed facades of the original store for early building fabric and features, or evidence of the same.

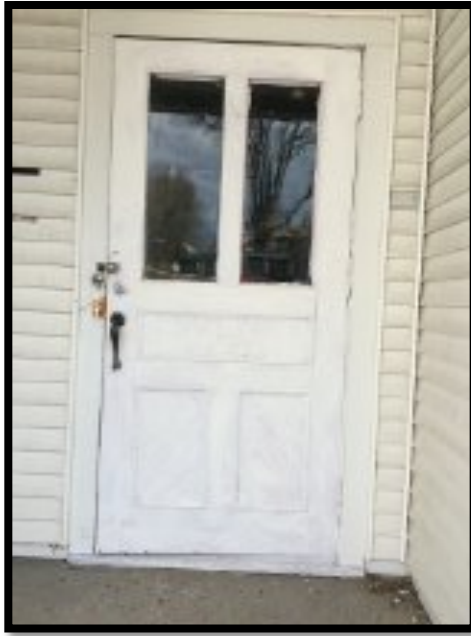
- **Doors.** The one remaining early entry is located on the north side of the rear wing, and features a glass-and-panel door with plain trim (photo 5). The door is composed of two vertical glass lights above three recessed panels (the upper one horizontal and lower two vertical) with diagonal bead-board fields. The door is hung on cast iron butt hinges; the door handle appears to be a replacement.

Photo 5. Fox-Seal General Store. Rear ell entry, looking south.

- **Entries/porches.** The original rear entry door and trim on the north side of the original rear wing must be preserved, but maybe rehung to open out, if necessary, to meet code requirements. The non-historic rear wing porch may be removed, if necessary, to achieve adaptive reuse purposes. However, if the porch is retained, its treatment must be sympathetic to the historic character of the building and consistent with physical evidence and historical documentation. Minor changes on the rear and side elevations are permitted, if necessary, for providing access and egress necessary to achieve adaptive reuse purposes. Upon the removal of the front appendage, any physical evidence of the 19th century storefront and porch should be preserved and recorded to help guide reconstruction of these elements.

- Rehabilitate/restore rear wing entry on physical and historic evidence; door may be rehung to swing outwards, if necessary, to meet code requirements.

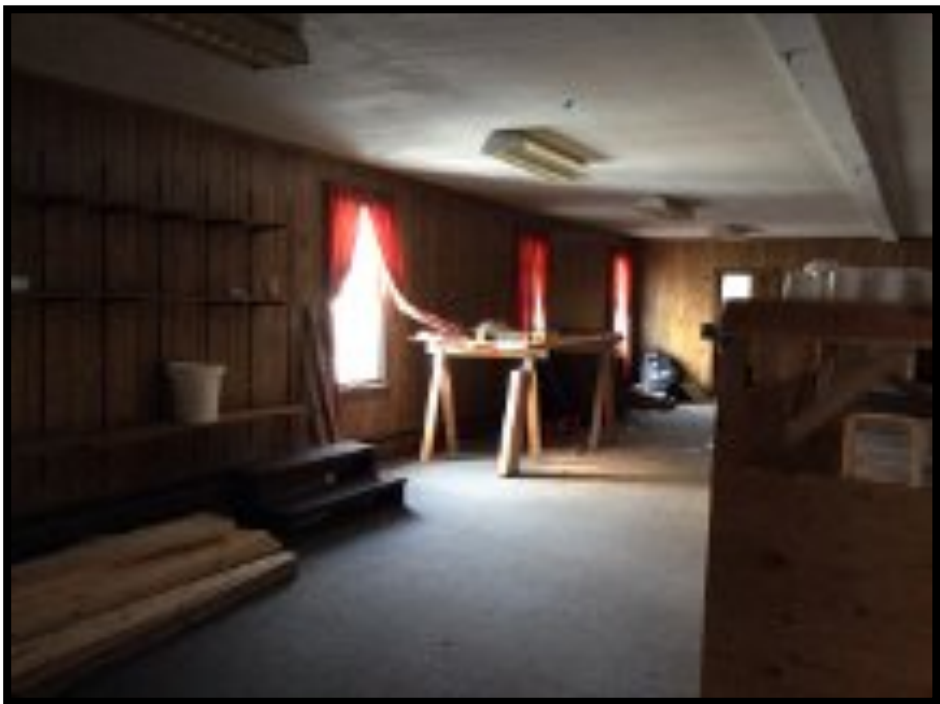
large room (photo 6). Finishes throughout are mid/late 20th century. The north windows on the second story retain early trim with simple bead moldings typical of the 19th century (photo 7).

Photo 6. Fox-Seal General Store. Original block, second story, looking NE towards early windows

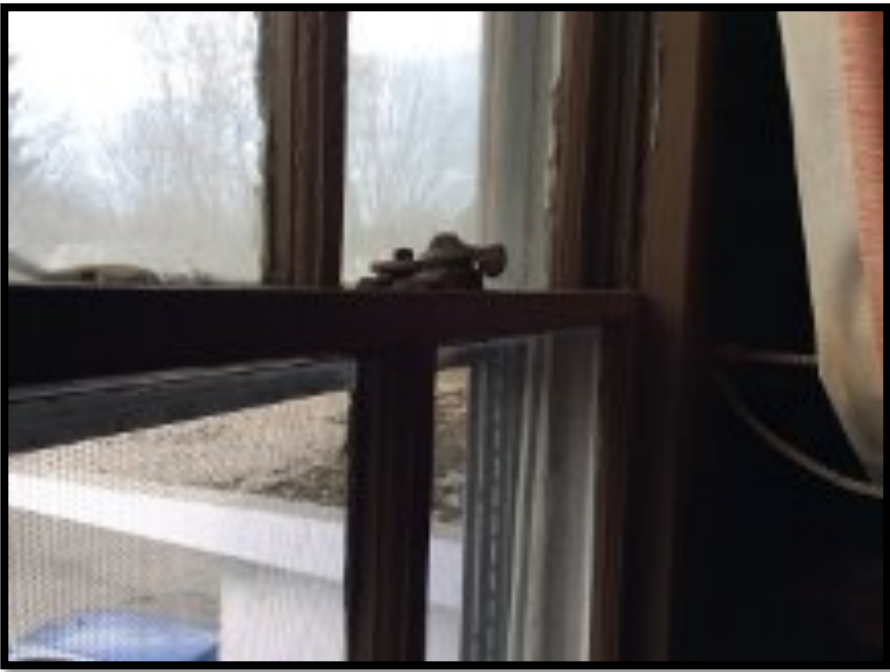
Photo 7. Fox-Seal General Store. Original block, second story, north window detail, looking NE, northeast view.

- **Floors, walls, ceilings and trim.** Modern floor, wall and ceiling treatments may be removed, and the replacement treatments necessary to achieve adaptive reuse purposes should be sympathetic to the historic character of the building. Consideration should be given to the preservation of any extant early fabric, particularly the original window trim of the second-story north windows, if it can be accommodated into proposed adaptive reuse program.

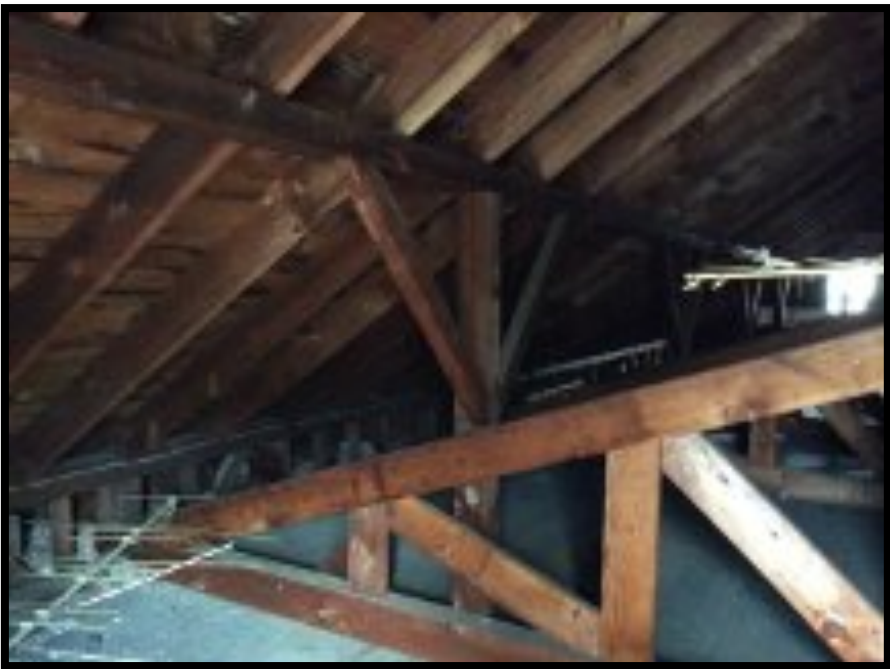
The interior the 1880s store main block and rear ell has been subject to considerable alteration over the years. The framing of the roof and attic floor remains intact (photos 8, 9, 10 and 11), as do presumably the flooring frames of the first and second stories. The original interior floor plan is unknown, although there likely one or more large rooms served to accommodate commercial functions. The first story of the main block currently is divided into a number of rooms, while the second story is one

Photo 8. Fox-Seal General Store. Original block attic, roof framing and south wall detail, looking SE.

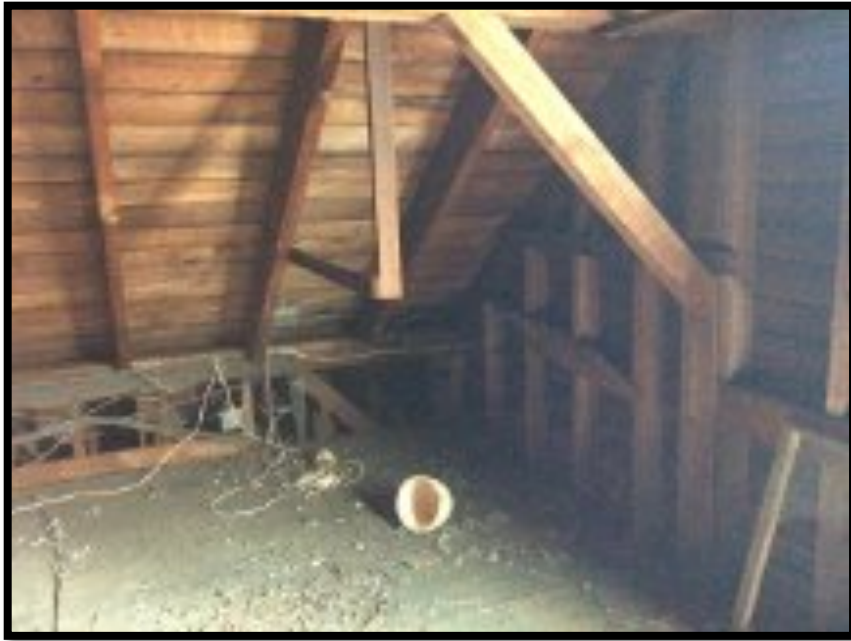
- **Siding.** Building is now covered with synthetic siding. What evidently is original clapboard siding can be seen in the attic on the main block's west gable (photos 9 and 11), and clapboard siding presumably also survives intact beneath the synthetic siding on the north and east sides of the main block and the north side of the rear ell, as evidenced by the survival of the original fenestration in these areas. Whether or not original siding remains on the other sides of the building behind the later additions is unknown. The original exterior east and south walls of the main block appears to have survived, although modified extensively, and it is possible that some siding may remain.

Photo 9. Fox-Seal General Store. Original block attic, SE corner, roof and wall framing, revealing original clapboard on west gable.

- **Siding.** Upon the removal of the synthetic siding, all exposed original clapboard siding and trim such as corner boards must be preserved and repaired utilizing techniques that are consistent with the Secretary of the Interior's *Standards for Historic Preservation*. Any siding that is too deteriorated to repair may be removed, as necessary, but must be replaced in kind in a manner that is consistent with physical evidence and historical documentation. Similarly, any areas of missing siding and trim must be in-filled to match the existing in accordance with physical evidence and historical documentation.

- Restore/rehabilitate original clapboard siding and trim; replace missing or severely damaged siding and trim based on physical and historical evidence.

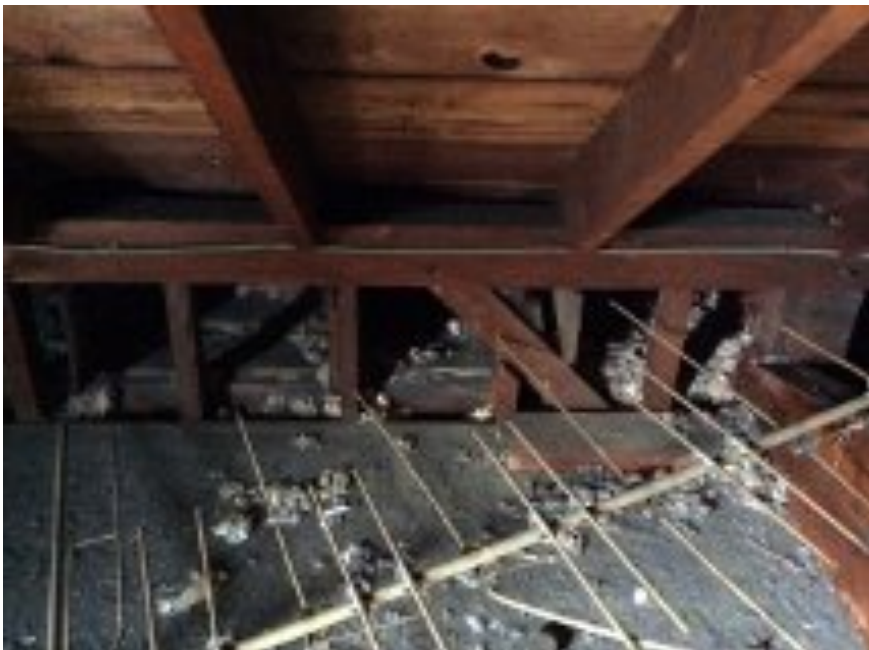
Photo 10. Fox-Seal General Store. Original block attic, north wall, eaves detail with cornice blocking.

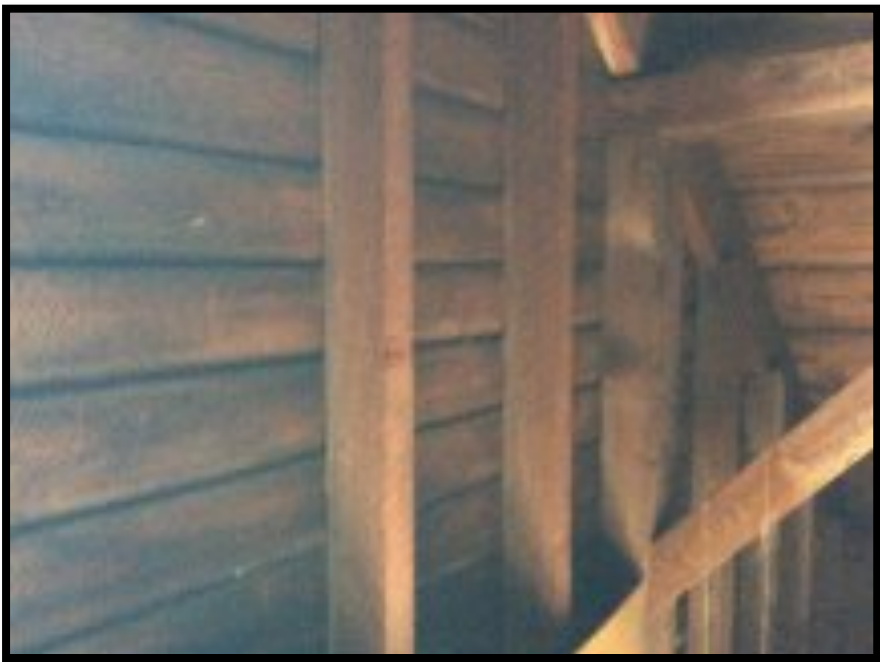
Photo 11. Fox-Seal General Store. Original block attic, west gable detail, revealing original clapboard siding, looking NW.
