Architectural Documentation
of the
HEADLEY HOUSE

Annandale Historic District
Clinton Township
Hunterdon County
New Jersey

May 5, 2008

This project is the result of the need to document existing architectural conditions of the house before it is demolished as part of the proposed residential redevelopment project.

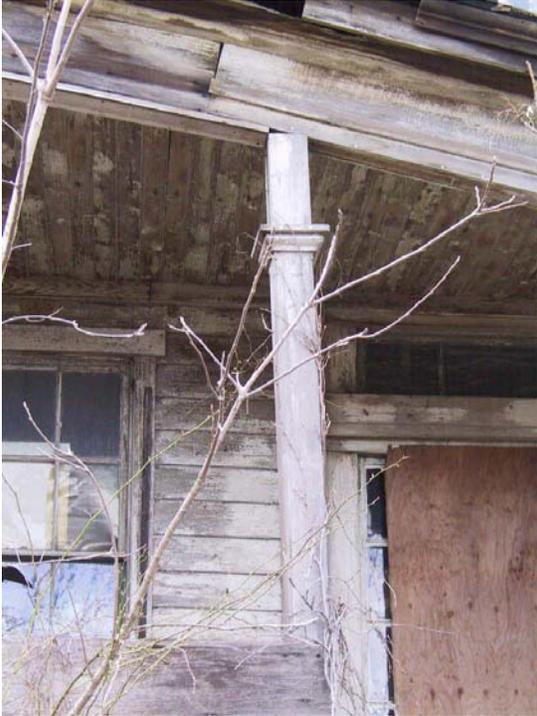
Porch post and entablature

The porch, now partially collapsed, has a flat roof, narrow board ceiling, deep entablature with a belt trim and box cornice and chamfered square posts with cap trim.

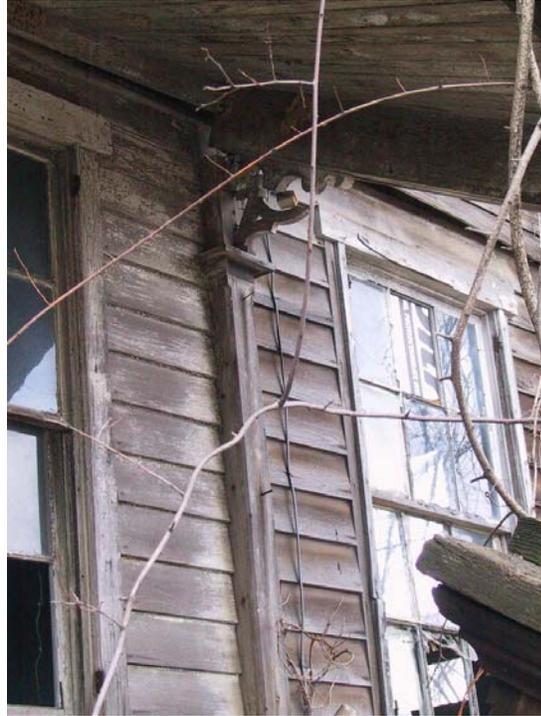
Front porch pilaster and bracket

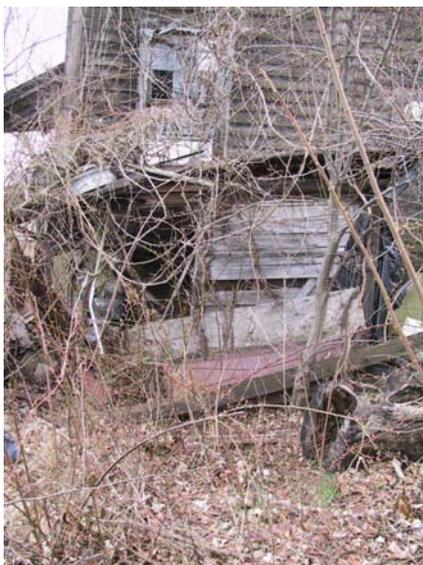
On the driveway side (East) of the house is a boarded up cellar access in the Southeast corner with what appears to be a 20th century shed addition adjacent to it.

Overgrown shed addition

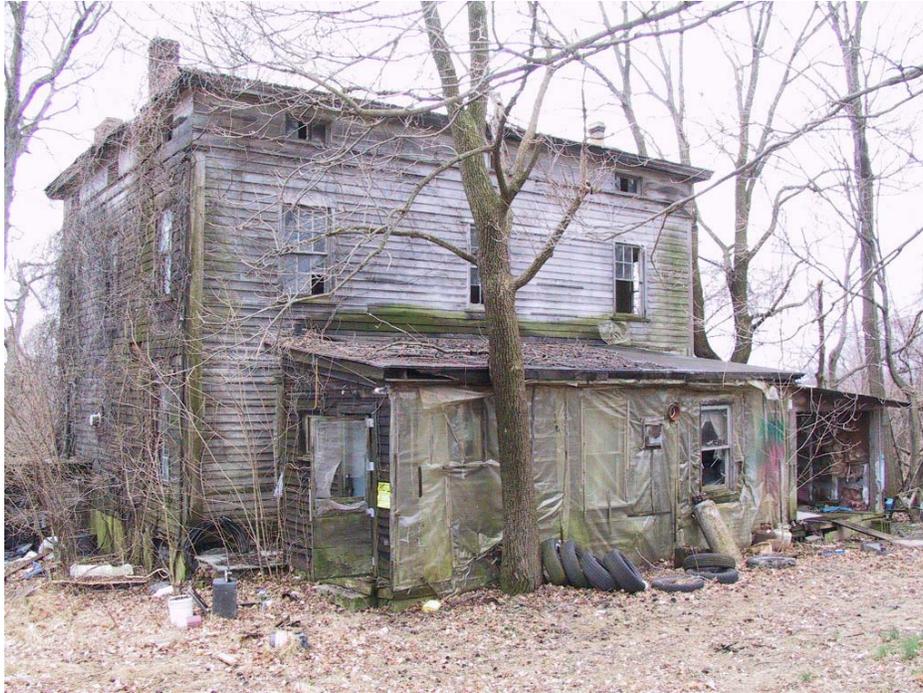
Northeast elevation

To the rear, North side of the house are 20th century additions with shed roofs which house the rear entrance, kitchen and garage. No inspection was made to ascertain if these additions were replacements for an earlier wing, but visible evidence showed they were newer additions, poorly constructed and had no historical value.

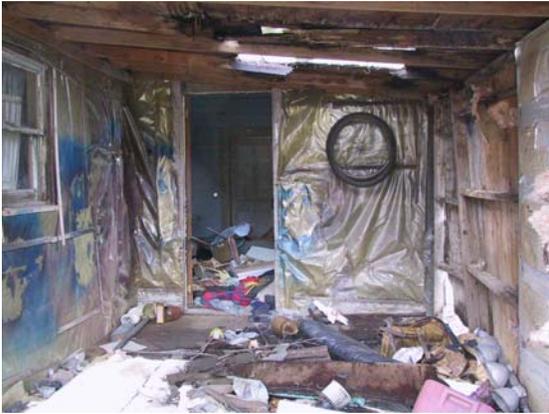
The additions off of the North side have no historical value. The garage is apparently 20th century construction and from the kitchen wing, the rear of the main block of the house shows clapboard siding which suggests that there was no other wing on the house originally.

Garage addition looking South

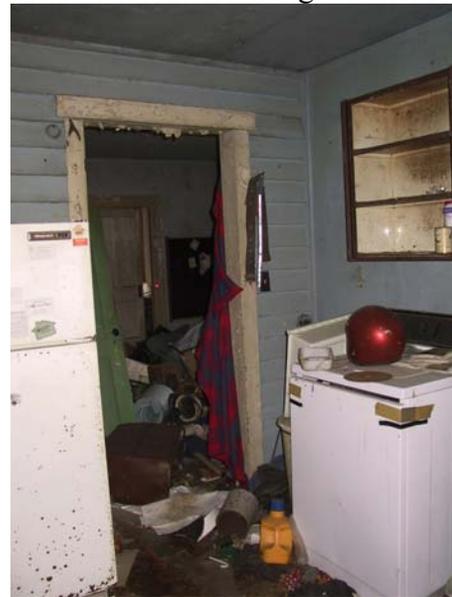
Room 106 looking South
Note siding and exterior trim
on main block of house

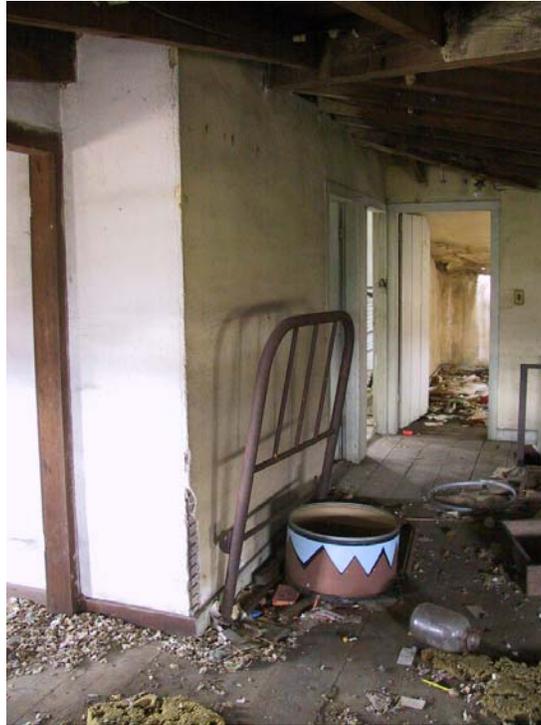
Room 122 looking West

Room 122, the common room at the top of the attic stairs, has an unfinished exposed rafter system. Principal rafters run from the corner of the house to two points in the center of the building creating the hip roof and common rafters run from the low top plate to the principal rafters.

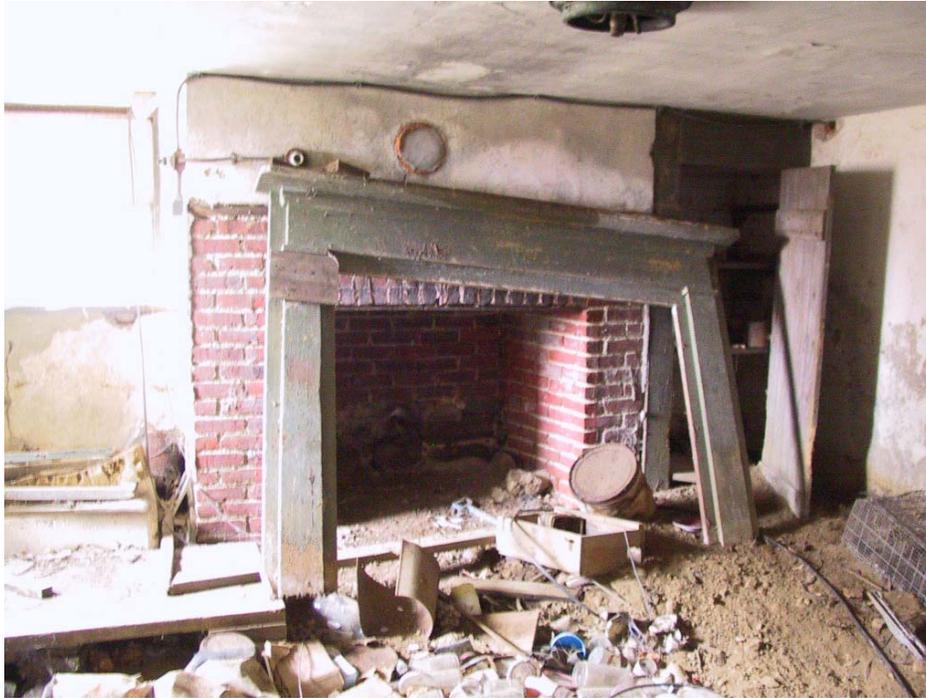
Room B101 looking West

The basement has a dirt floor. The dirt is stepped between the front two rooms (B101 & B102) and the rear room (B103). Rooms B101 and 102 were the cooking rooms. They are finished with plaster and may have had wood plank floors at one time. Room B103 is unfinished as a utility and storage area.

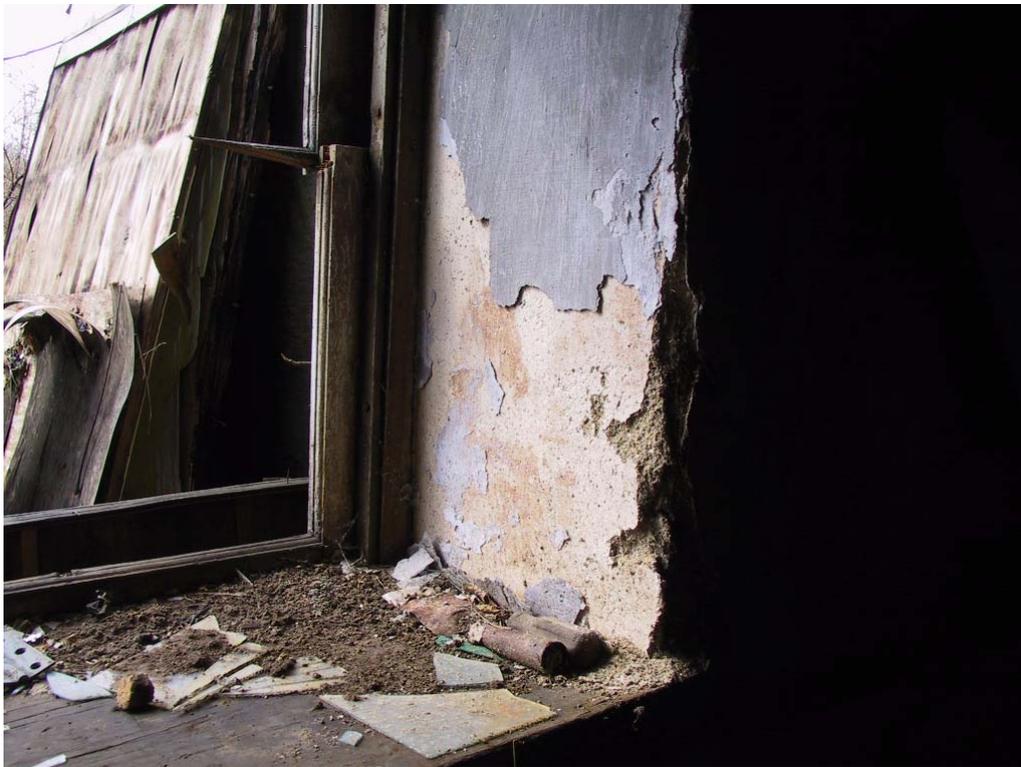
Room B102 window and masonry opening

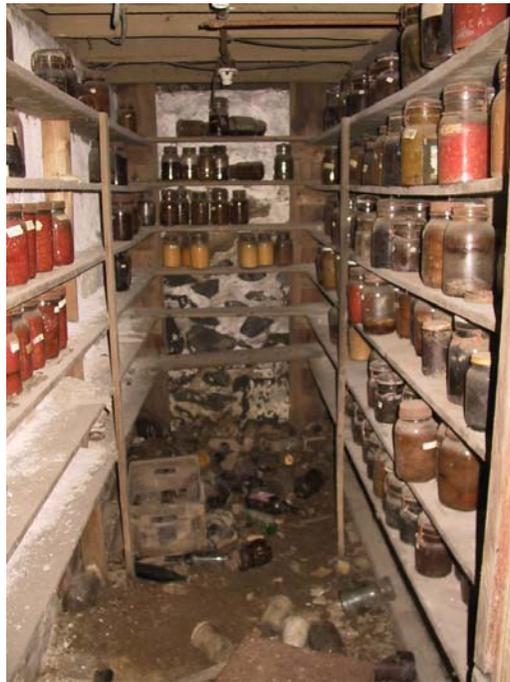
Room 103 canning storage

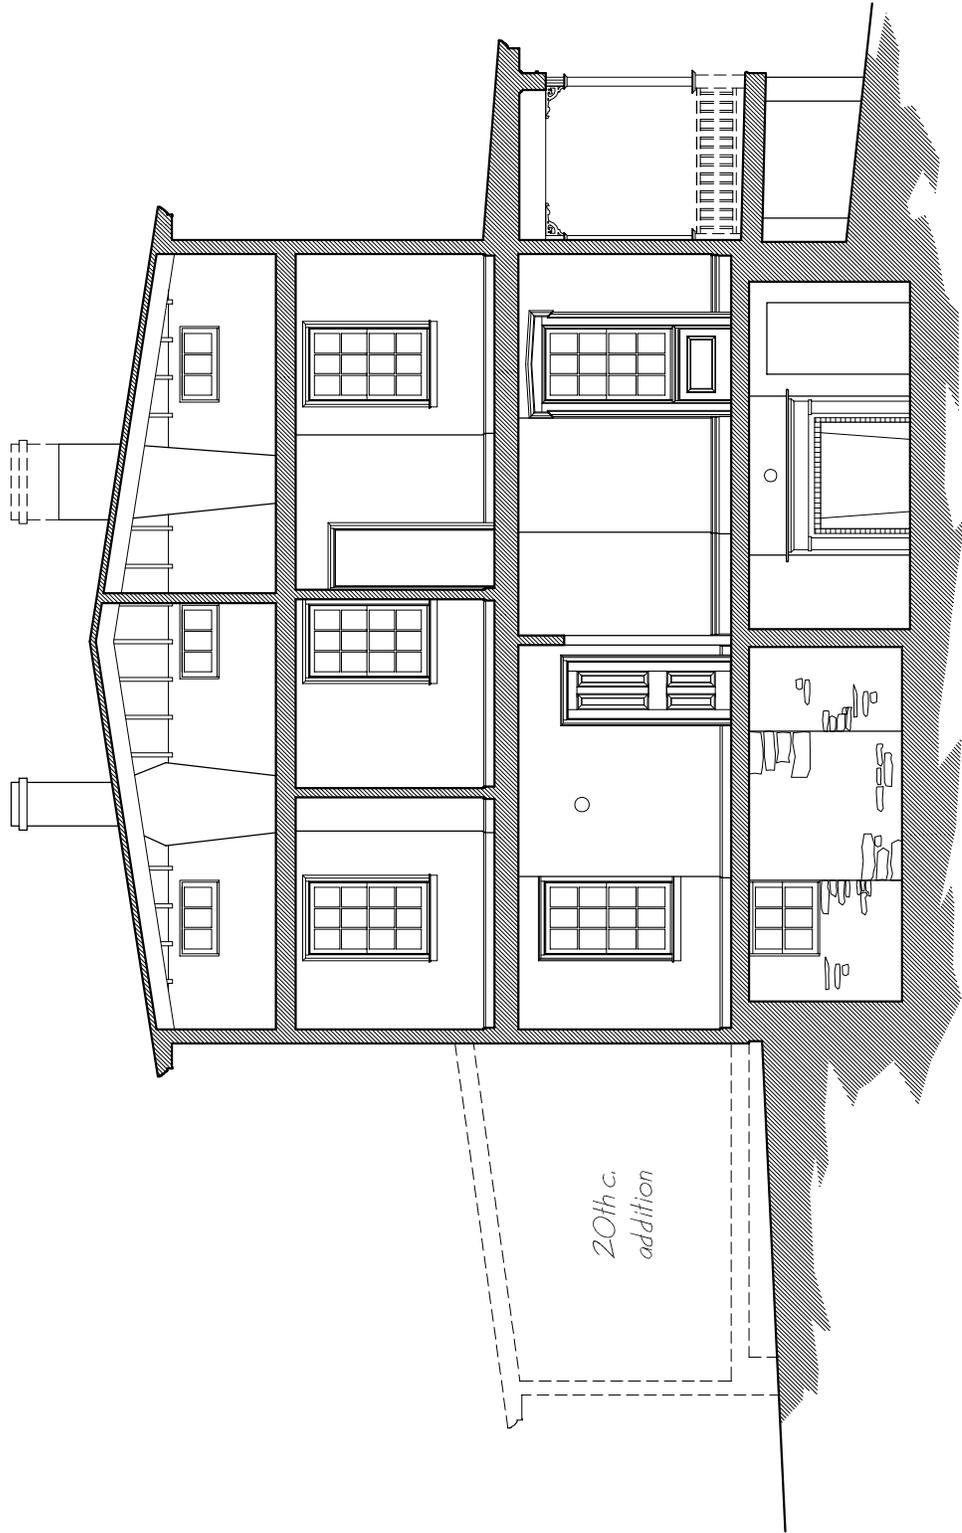
Building Section Looking East

20th c.
addition
